## 藤原宮朝堂院における 儀式遺構の発見

## Discovery of Ritual Features in the State Halls Compound, Fujiwara Palace

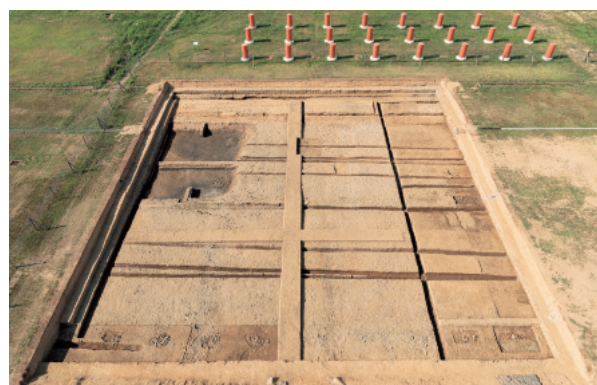
第189次調査区全景（南から）

Panoramic view of the investigated area of excavation No. 189 (from the south)

そこで、2016年度の第189次調査では、第153次調査区のすぐ西側に調査区を設け、第153次調査でみついていた柱穴の西側の対称位置にも、同様の柱穴が存在するかを確かめる調査をおこないました。その結果、予想通り東側と対称の位置に3基の大型柱穴を発見しました。これにより、ついに7基の大型柱穴からなる幢幡遺構の全容が明らかになったのです。

Then, in investigation No. 189 of the 2016 fiscal year, an excavation precinct was set up just west of that of excavation No. 153, and investigation was undertaken to confirm whether similar post holes existed at locations symmetrically opposite those discovered in the previous excavation. As a result, three large post holes were discovered as expected in symmetrical fashion to those on the eastern side. With this, the banner feature comprised of seven large post holes came to light.

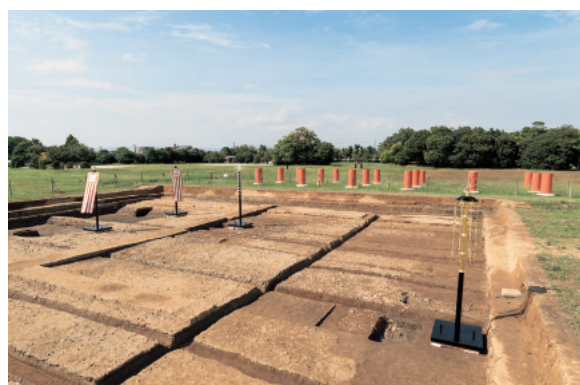
幢幡遺構と復元した幢幡（南から）

Banner features with replicated banners (from the south)

この幢幡遺構は、藤原宮中軸上に1基、その東西にそれぞれ3基が三角形をなすように、合計7基の大型柱穴を配置するものです。幢幡遺構を『続日本紀』の記述から復元すれば、中央に鳥形幡、その東に日像、西に月像、東北に青龍幡、南東に朱雀幡、西北に玄武幡、西南に白虎幡となります。

This banner feature has a total of seven large post holes arranged with one lying on the central axis of the Fujiwara palace, and the others forming triangular shapes to its east and west. Reconstructing the feature based on the *Shoku Nihongi* description, the crow banner would be placed in the center, with the sun to its east and moon to its west, then Seiryū and Suzaku to the northeast and southeast, and Genbu and Byakko to the northwest and southwest.
